**Subject:        Site Assessment Report, Revision 0**  
**Superior Cleaning Solutions Site (Keowee Street Drum Site)**  
**EPA Contract No.: EP-S5-10-10**  
**Technical Direction Document (TDD) No.: TO-05-11-06-0016**

# **SITE ASSESSMENT REPORT**

**Superior Cleaning Solutions Site  
(Keowee Street Drum Site)  
Dayton, Montgomery County, Ohio**

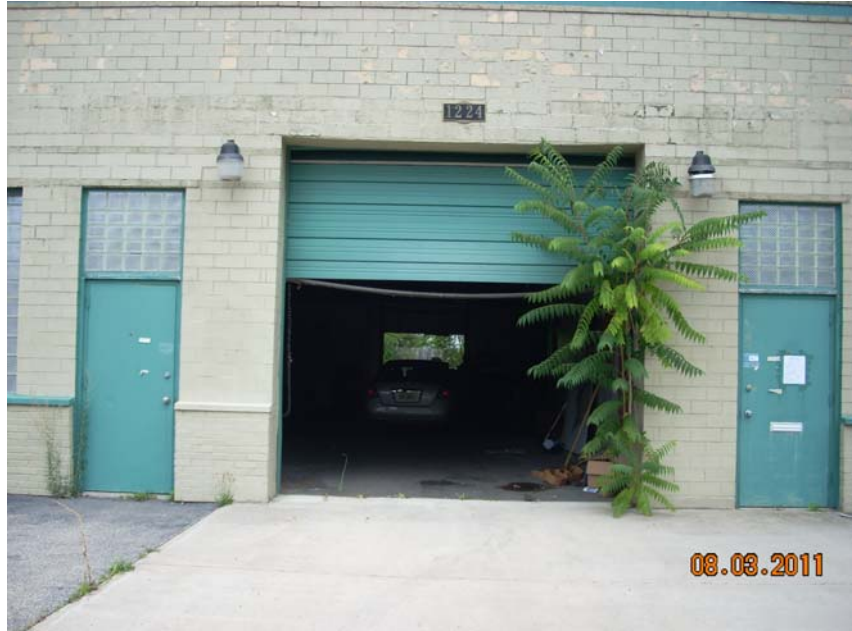
**Photograph No.:** 1      **Photographer:** Stacey DeLaReintrie      **Orientation:** East  
**TDD Number:** TO-05-11-06-0016      **Contract:** EP-S5-10-10      **Date:** August 3, 2011  
**Site Name & Location:** Keowee Street Drum Site, Dayton, OH  
**Subject:** Superior Cleaning Solutions building exterior.

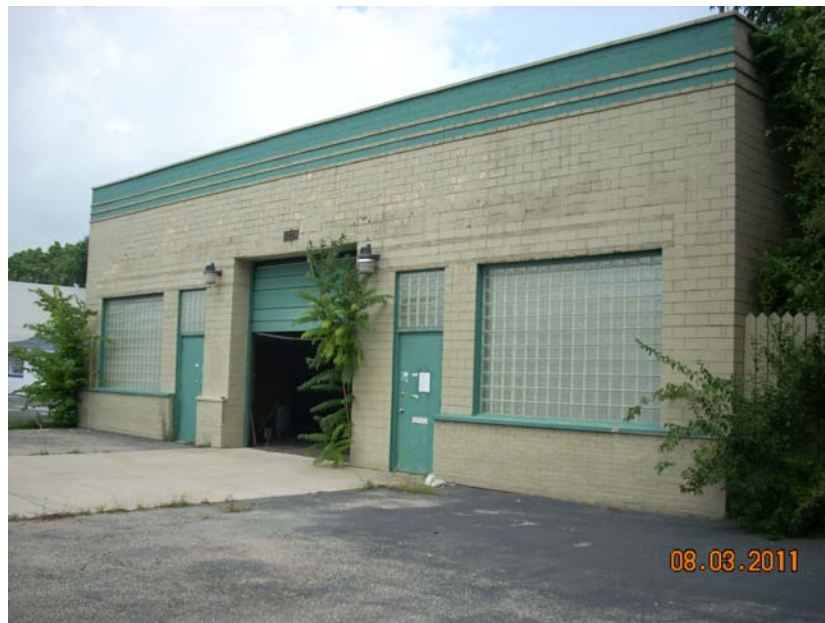
**Photograph No.:** 2      **Photographer:** Stacey DeLaReintrie      **Orientation:** Northeast  
**TDD Number:** TO-05-11-06-0016      **Contract:** EP-S5-10-10      **Date:** August 3, 2011  
**Site Name & Location:** Keowee Street Drum Site, Dayton, OH  
**Subject:** Superior Cleaning Solutions building exterior.

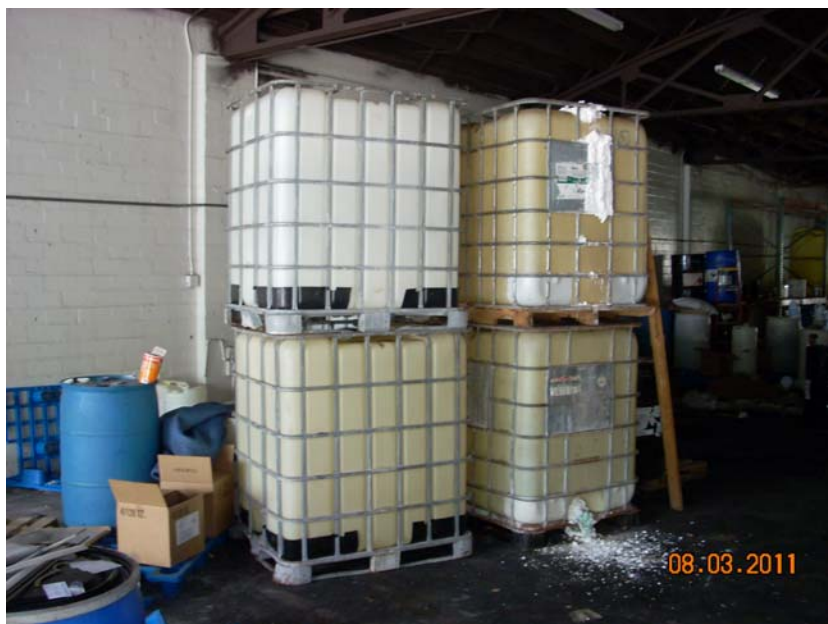
**Photograph No.:** 3                      **Photographer:** Stacey DeLaReintrie    **Orientation:** Northeast  
**TDD Number:** TO-05-11-06-0016    **Contract:** EP-S5-10-10                      **Date:** August 3, 2011  
**Site Name & Location:** Keowee Street Drum Site, Dayton, OH  
**Subject:** Totes located inside the building.

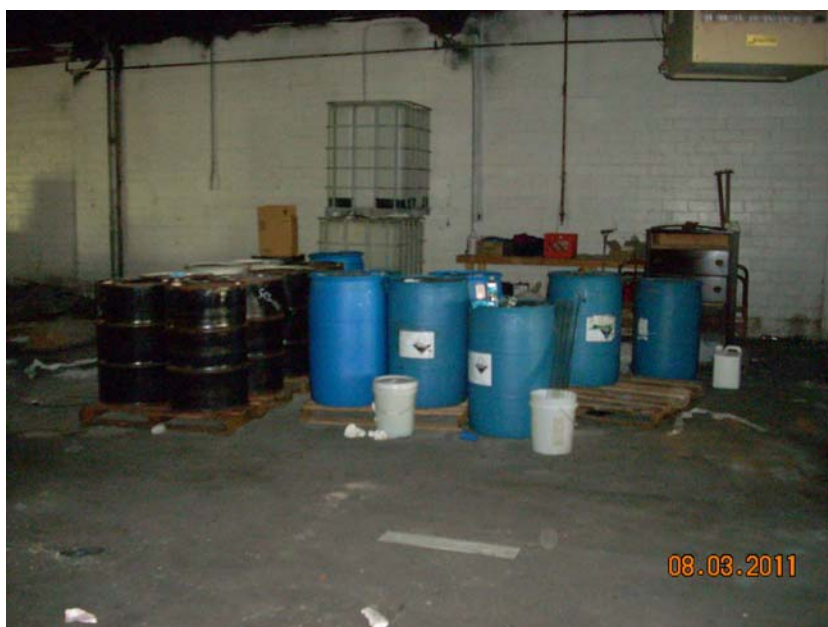
**Photograph No.:** 4                      **Photographer:** Stacey DeLaReintrie    **Orientation:** South  
**TDD Number:** TO-05-11-06-0016    **Contract:** EP-S5-10-10                      **Date:** August 3, 2011  
**Site Name & Location:** Keowee Street Drum Site, Dayton, OH  
**Subject:** Miscellaneous drums and containers located inside the building.

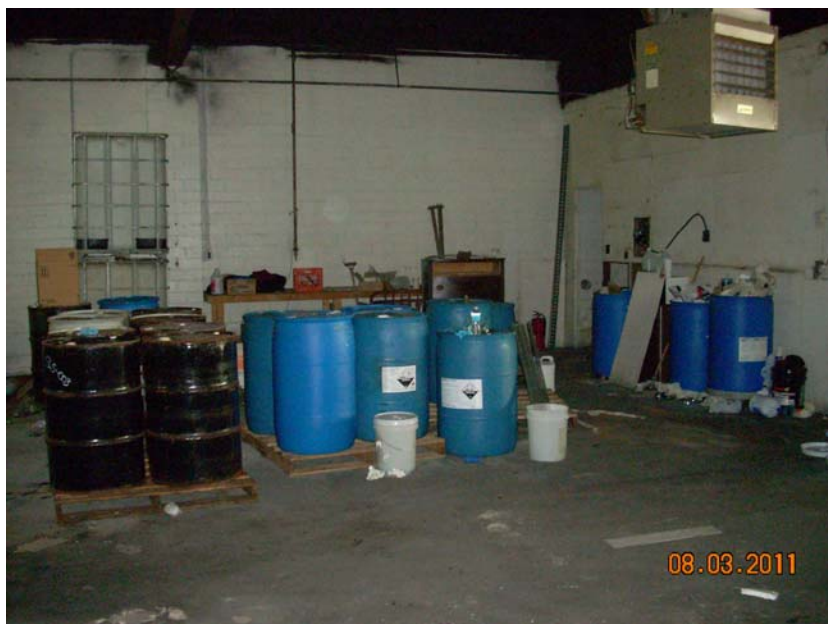
**Photograph No.:** 5                      **Photographer:** Stacey DeLaReintrie   **Orientation:** South  
**TDD Number:** TO-05-11-06-0016   **Contract:** EP-S5-10-10       **Date:** August 3, 2011  
**Site Name & Location:** Keowee Street Drum Site, Dayton, OH  
**Subject:** Miscellaneous drums and containers located inside the building.

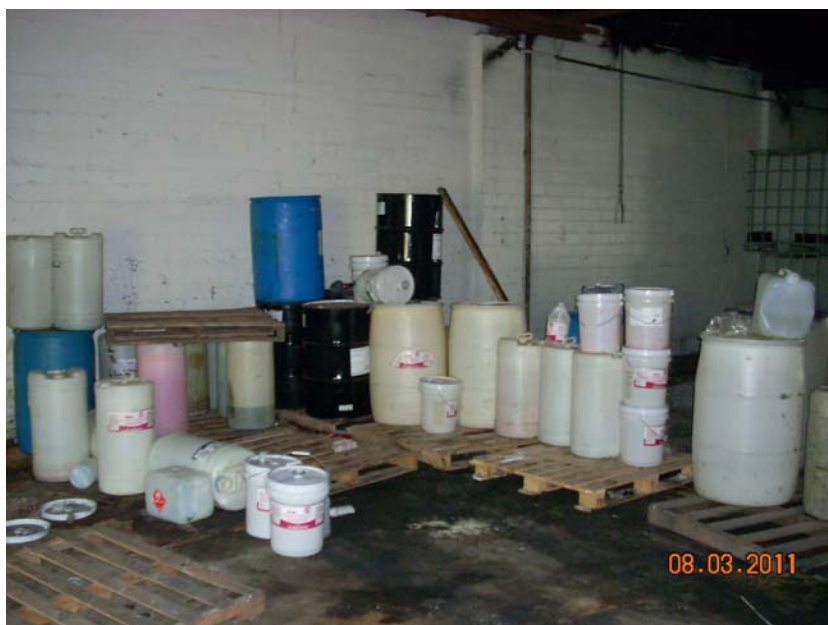
**Photograph No.:** 6                      **Photographer:** Stacey DeLaReintrie   **Orientation:** South  
**TDD Number:** TO-05-11-06-0016   **Contract:** EP-S5-10-10       **Date:** August 3, 2011  
**Site Name & Location:** Keowee Street Drum Site, Dayton, OH  
**Subject:** Miscellaneous drums and containers located inside the building.

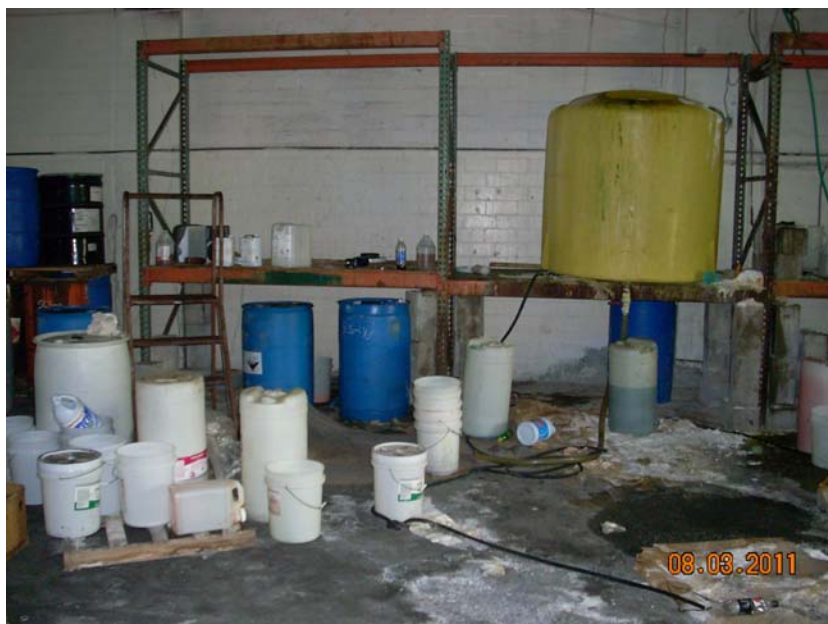
**Photograph No.:** 7                      **Photographer:** Stacey DeLaReintrie    **Orientation:** North  
**TDD Number:** TO-05-11-06-0016    **Contract:** EP-S5-10-10                      **Date:** August 3, 2011  
**Site Name & Location:** Keowee Street Drum Site, Dayton, OH  
**Subject:** Suspected mixing tank and miscellaneous drums and containers.

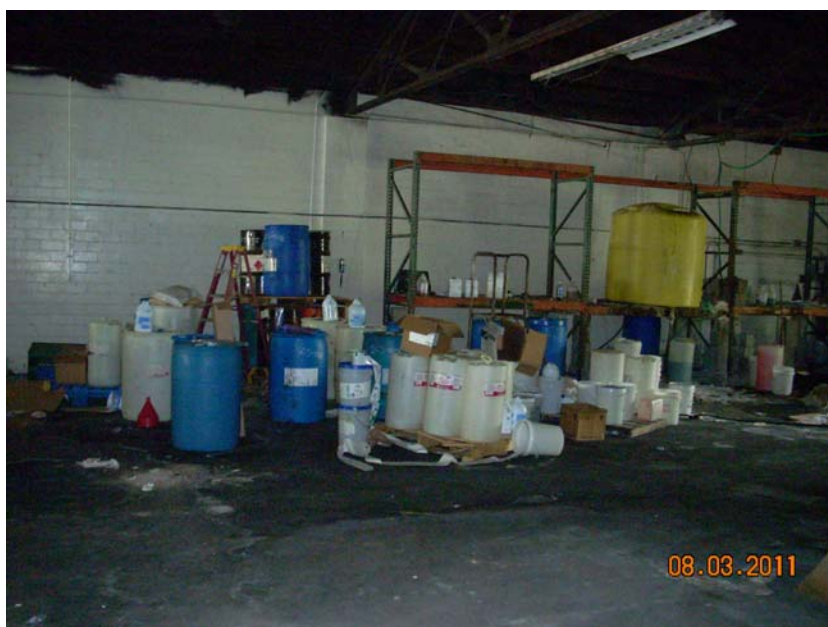
**Photograph No.:** 8                      **Photographer:** Stacey DeLaReintrie    **Orientation:** North  
**TDD Number:** TO-05-11-06-0016    **Contract:** EP-S5-10-10                      **Date:** August 3, 2011  
**Site Name & Location:** Keowee Street Drum Site, Dayton, OH  
**Subject:** Suspected mixing tank and miscellaneous drums and containers.

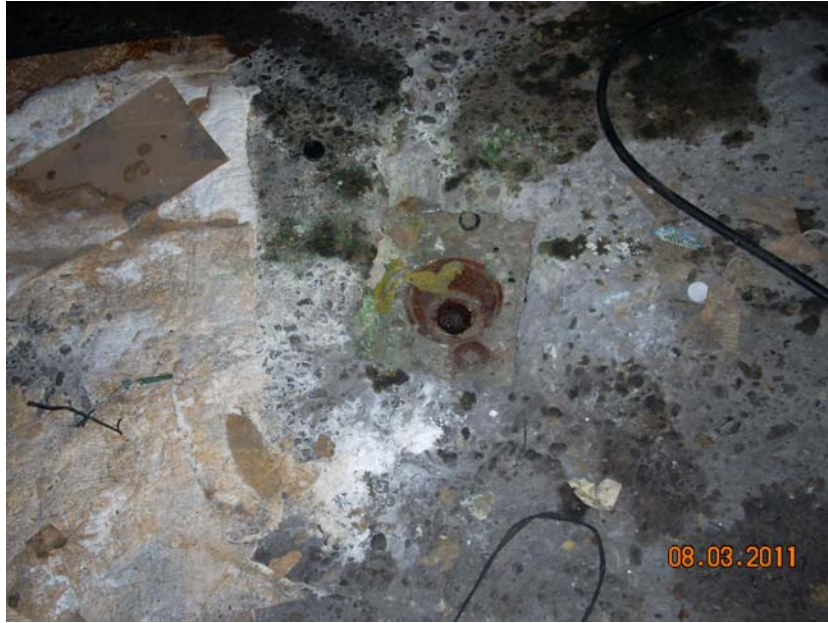
**Photograph No.:** 9                      **Photographer:** Stacey DeLaReintrie    **Orientation:** Looking down  
**TDD Number:** TO-05-11-06-0016    **Contract:** EP-S5-10-10                      **Date:** August 3, 2011  
**Site Name & Location:** Keowee Street Drum Site, Dayton, OH  
**Subject:** Floor drain located inside the building near the mixing tank.

EPA samples confirmed the presence of ignitable, corrosive, and toxic (xylene) hazardous waste at the site. Drum contents were observed spilled onto the floor and adjacent floor drain area. Numerous drums and containers were uncovered and deteriorating, with visible waste spilled onto the floor in various areas on-site. Continued deterioration of the containers on site may allow additional quantities of hazardous substances to migrate into the environment.

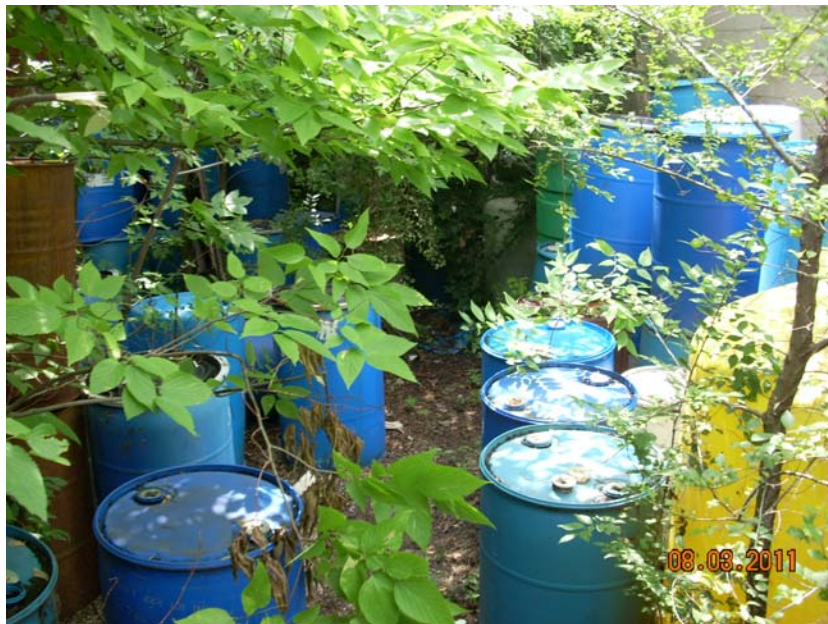
**Photograph No.:** 10                      **Photographer:** Stacey DeLaReintrie    **Orientation:** West  
**TDD Number:** TO-05-11-06-0016    **Contract:** EP-S5-10-10                      **Date:** August 3, 2011  
**Site Name & Location:** Keowee Street Drum Site, Dayton, OH  
**Subject:** Drums located outside along the south side of the building.

There is a wood gate at the rear of the property that encloses unsecured 55 gallon drums along the south side of the site building. Also there is an overgrowth of trees and brush behind the building. Drums containing sodium hydroxide and xylene chemicals and several unknown chemical drums are located inside and outside the building.
